EXECUTIVE SUMMARY

Forefront Emergency Management, L.P. (Forefront EM) was contracted by The City of Thibodaux (User) to perform a Phase I Environmental Site Assessment (ESA) of the property located at 1229 Canal Boulevard, Thibodaux, Louisiana 70301 (Lafourche Parish). The purpose of the ESA was to identify recognized environmental conditions that may exist on the property through site reconnaissance, interviews, and review of available state, federal, and historical records. The ESA was performed in conformance with the American Society for Testing and Materials (ASTM) E1527-21 Standard Practice. The ASTM E1527-21 Standard Practice defines a recognized environmental condition as:

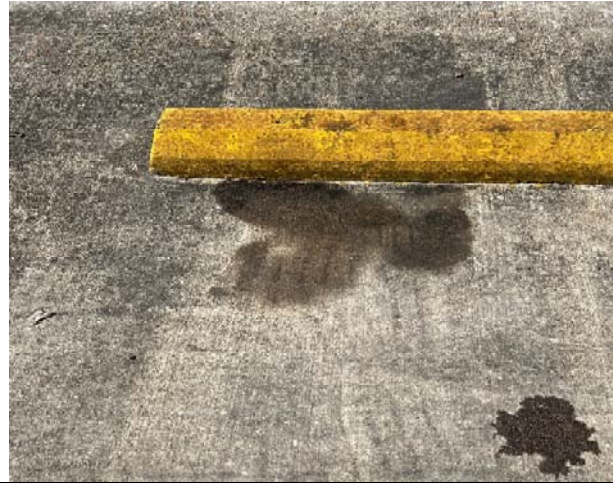
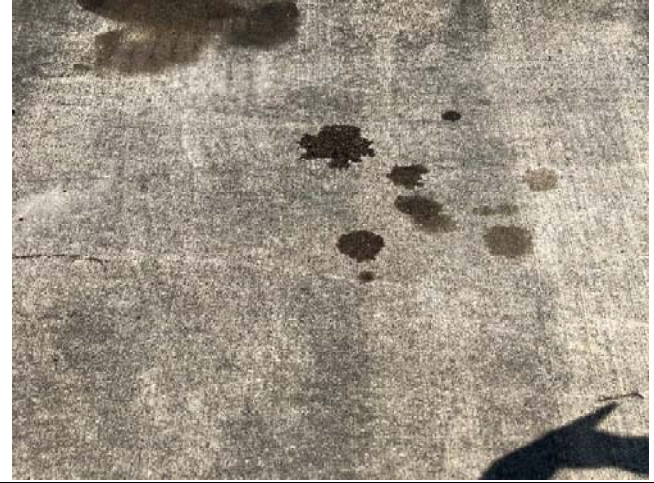
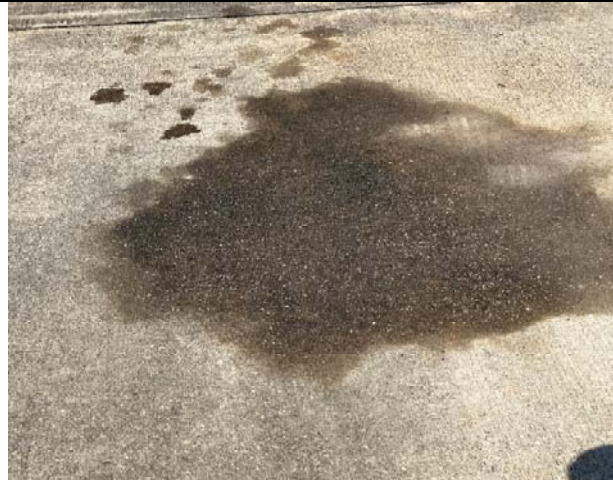
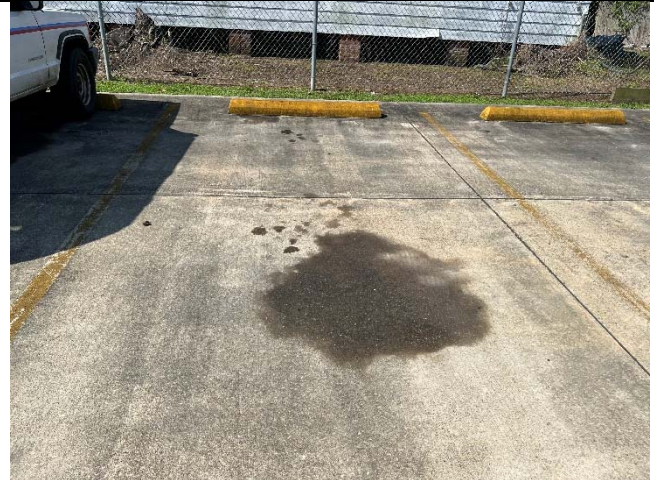
Hydrocarbon staining was observed in the eastern parking lot bordering President Street on the southeastern side of the parking lot. GPS Coordinates: 29.788050, -90.821560. With rainfall, some the hydrocarbons could potentially runoff into one of the three storm drains located within the parking lot.

Appropriately remove/clean the hydrocarbon staining and properly dispose of any wastewater and/or solid materials created or used during the removal/cleaning.

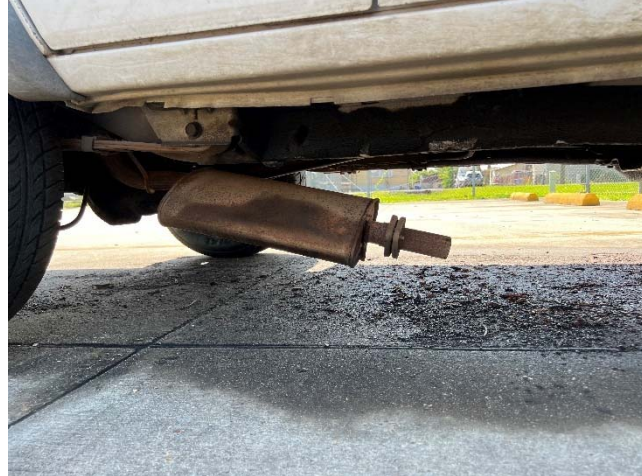
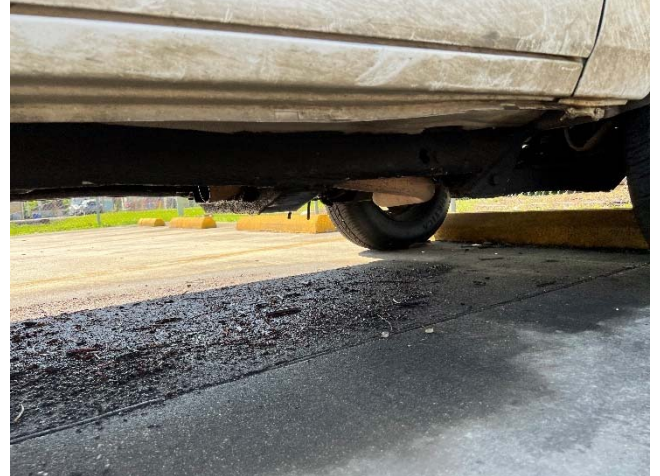
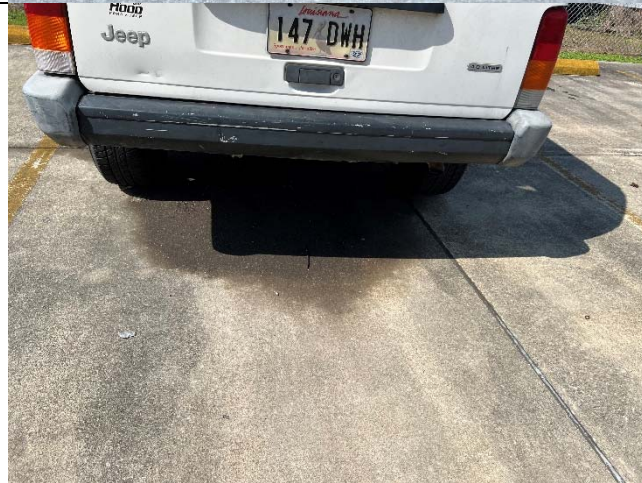
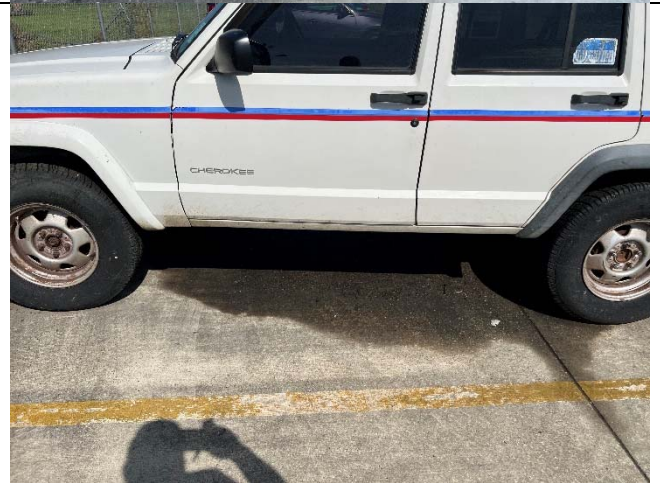
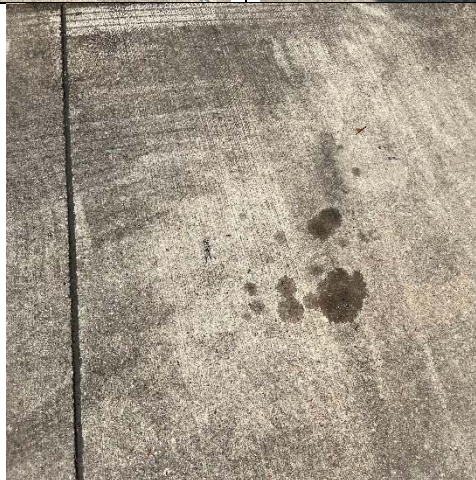
Hydrocarbon staining was observed in the eastern parking lot bordering President Street on the southeastern side of the parking lot underneath and around a U.S. Mail vehicle (Jeep Cherokee, Louisiana license plate number: 147 DWH). GPS Coordinates: 29.788050, -90.821560. With rainfall, some the hydrocarbons could potentially runoff into one of the three storm drains located within the parking lot.

Appropriately remove/clean the hydrocarbon staining and properly dispose of any wastewater and/or solid materials created or used during the removal/cleaning.

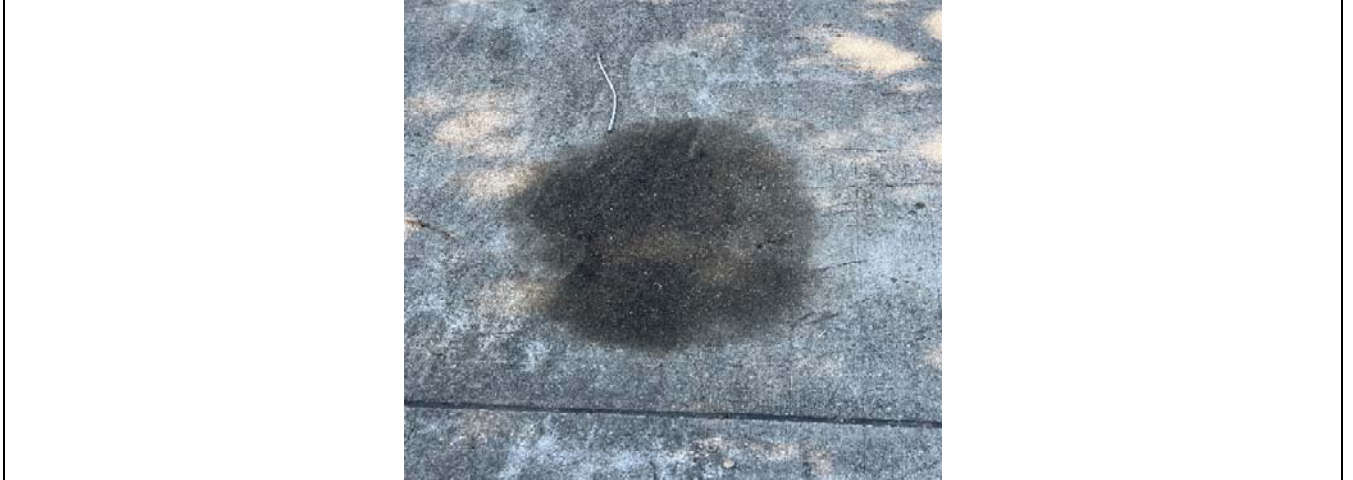
Hydrocarbon staining was observed in the eastern parking lot bordering President Street on the northeastern side of the parking lot. GPS Coordinates: 29.788070, -90.821400. With rainfall, some the hydrocarbons could potentially runoff into one of the three storm drains located within the parking lot.

Appropriately remove/clean the hydrocarbon staining and properly dispose of any wastewater and/or solid materials created or used during the removal/cleaning.
