EXECUTIVE SUMMARY

Forefront Emergency Management, L.P. (Forefront EM) was contracted by The City of Thibodaux (User) to perform a Phase I Environmental Site Assessment (ESA) of the property located at 1229 Canal Boulevard, Thibodaux, Louisiana 70301 (Lafourche Parish). The purpose of the ESA was to identify recognized environmental conditions that may exist on the property through site reconnaissance, interviews, and review of available state, federal, and historical records. The ESA was performed in conformance with the American Society for Testing and Materials (ASTM) E1527-21 Standard Practice. The ASTM E1527-21 Standard Practice defines a recognized environmental condition as:

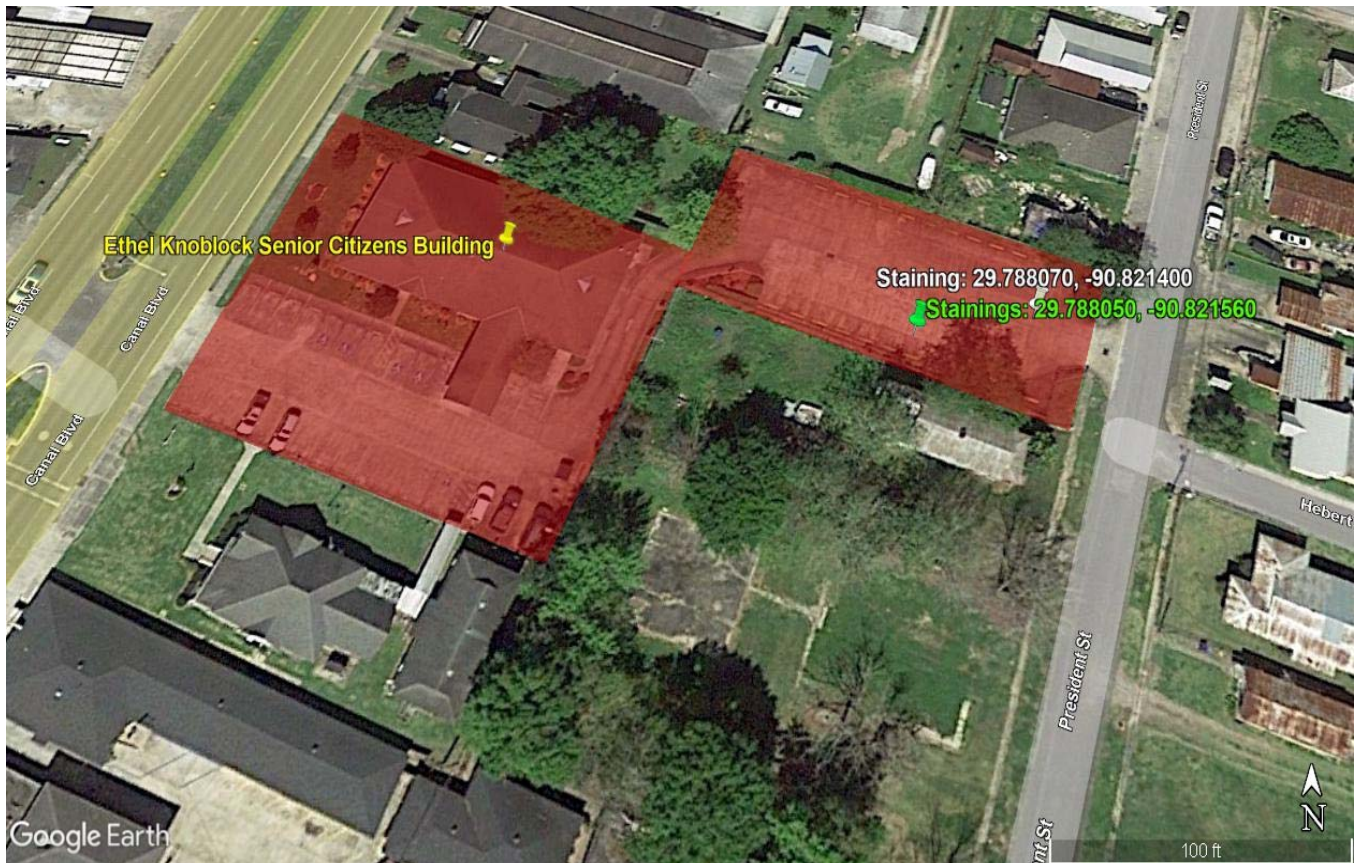
Hydrocarbon staining was observed in the eastern parking lot bordering President Street on the northeastern side of the parking lot. GPS Coordinates: 29.788070, -90.821400. With rainfall, some the hydrocarbons could potentially runoff into one of the three storm drains located within the parking lot.

Appropriately remove/clean the hydrocarbon staining and properly dispose of any wastewater and/or solid materials created or used during the removal/cleaning.
